DEPARTMENT OF TRANSPORTATION**DIVISION OF ENGINEERING SERVICES**

Contract #: 04-0120F4Cty: SF/ALA Rte: 80 PM: 13.2/13.9File #: 69.28**WELDING INSPECTION REPORT****Resident Engineer:**Pursell, Gary**Address:** 333 Burma Road**City:** Oakland, CA 94607**Report No:** WIR-000656**Date Inspected:** 17-Oct-2007**Project Name:** SAS Superstructure**OSM Arrival Time:** 630**Prime Contractor:** American Bridge/Fluor Enterprises, a JV**OSM Departure Time:** 1500**Contractor:** Zhenhua Port Machinery Company, Ltd (ZPMC), Changxing Island **Location:** Shanghai, China**CWI Name:** Zhang Xu Liang**CWI Present:** Yes No**Inspected CWI report:** Yes No N/A**Rod Oven in Use:** Yes No N/A**Electrode to specification:** Yes No N/A**Weld Procedures Followed:** Yes No N/A**Qualified Welders:** Yes No N/A**Verified Joint Fit-up:** Yes No N/A**Approved Drawings:** Yes No N/A**Approved WPS:** Yes No N/A**Delayed / Cancelled:** Yes No N/A**Bridge No:** 34-0006**Component:** Caltrans Mockup**Summary of Items Observed:**

Caltrans Quality Assurance (QA) Inspector, Mike Hasler was present to observe the fitup, welding and related activities associated with the fabricating of Caltrans Mock-up, 77M, 89M, 114M

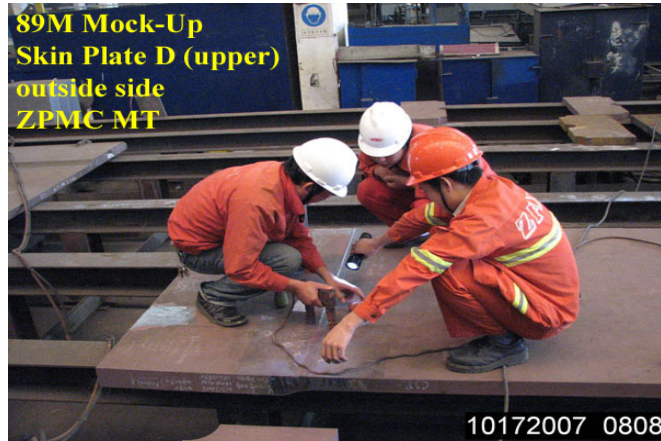
2	Skin Plate D (upper)	NA	NA	ZPMC MT
---	----------------------	----	----	---------

Mock-Up 89M, Skin Plate D (upper): Caltrans QA Inspector witnessed ZPMC Quality Control inspector, Mr. Zhou Dongyun perform magnetic particle test (MT) and Visual Test (VT) inspection at the partial joint penetration (PJP) and complete joint penetration (CJP) butt weld cover pass and eight attachment (lifting aid) removal locations. ZPMC MT coverage appeared to be 100 percent of the welds and attachment removal locations. The weld locations are identified as skin plate splice weld, mp509 to mp513 welds outside/inside side. The MT appeared to be in compliance with the project specification and found to be in compliant by QC.

Caltrans QA Inspector performed MT and VT inspection of the PJP, CJP and attachment removal locations. See

Caltrans Magnetic Particle Test Report, TL6028, generated on this date for additional information. Following digital picture illustrates ZPMC MT in progress.

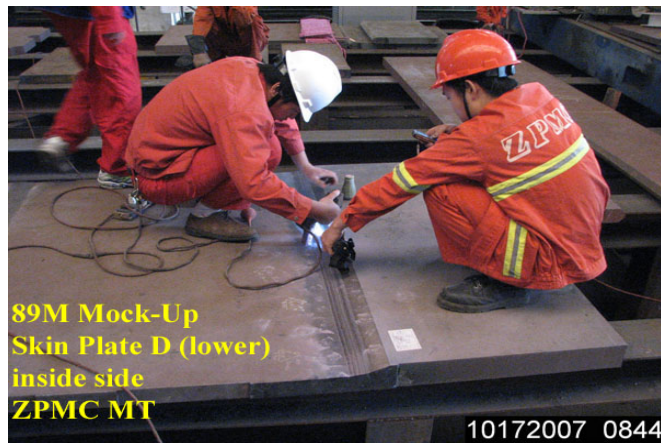
| 3 | Skin Plate D (lower) | NA | NA | ZPMC MT |

Mock-Up 89M, Skin Plate D (lower): Caltrans QA Inspector witnessed ZPMC Quality Control inspector, Mr. Cai Xin perform magnetic particle test (MT) and Visual Test (VT) inspection at the partial joint penetration (PJP) and complete joint penetration (CJP) butt weld cover pass and eight attachment (lifting aid) removal locations. ZPMC MT coverage appeared to be 100 percent of the welds and attachment removal locations. The weld locations are identified as skin plate splice weld, mp506 to MA 22 welds outside/inside side. The MT appeared to be in compliance with the project specification and found to be in compliant by QC.

Caltrans QA Inspector performed MT and VT inspection of the PJP, CJP and attachment removal locations. See Caltrans Magnetic Particle Test Report, TL6028, generated on this date for additional information. Following digital picture illustrates ZPMC MT in progress.
